NTSB-AAR-70-12

AIRCRAFT ACCIDENT REPORT

MOHAWK AIRLINES, INC.
FAIRCHILD HILLER FH-227B, N7811M
NEAR GLENS FALLS, NEW YORK
NOVEMBER 19, 1969

Adopted: June 25, 1970

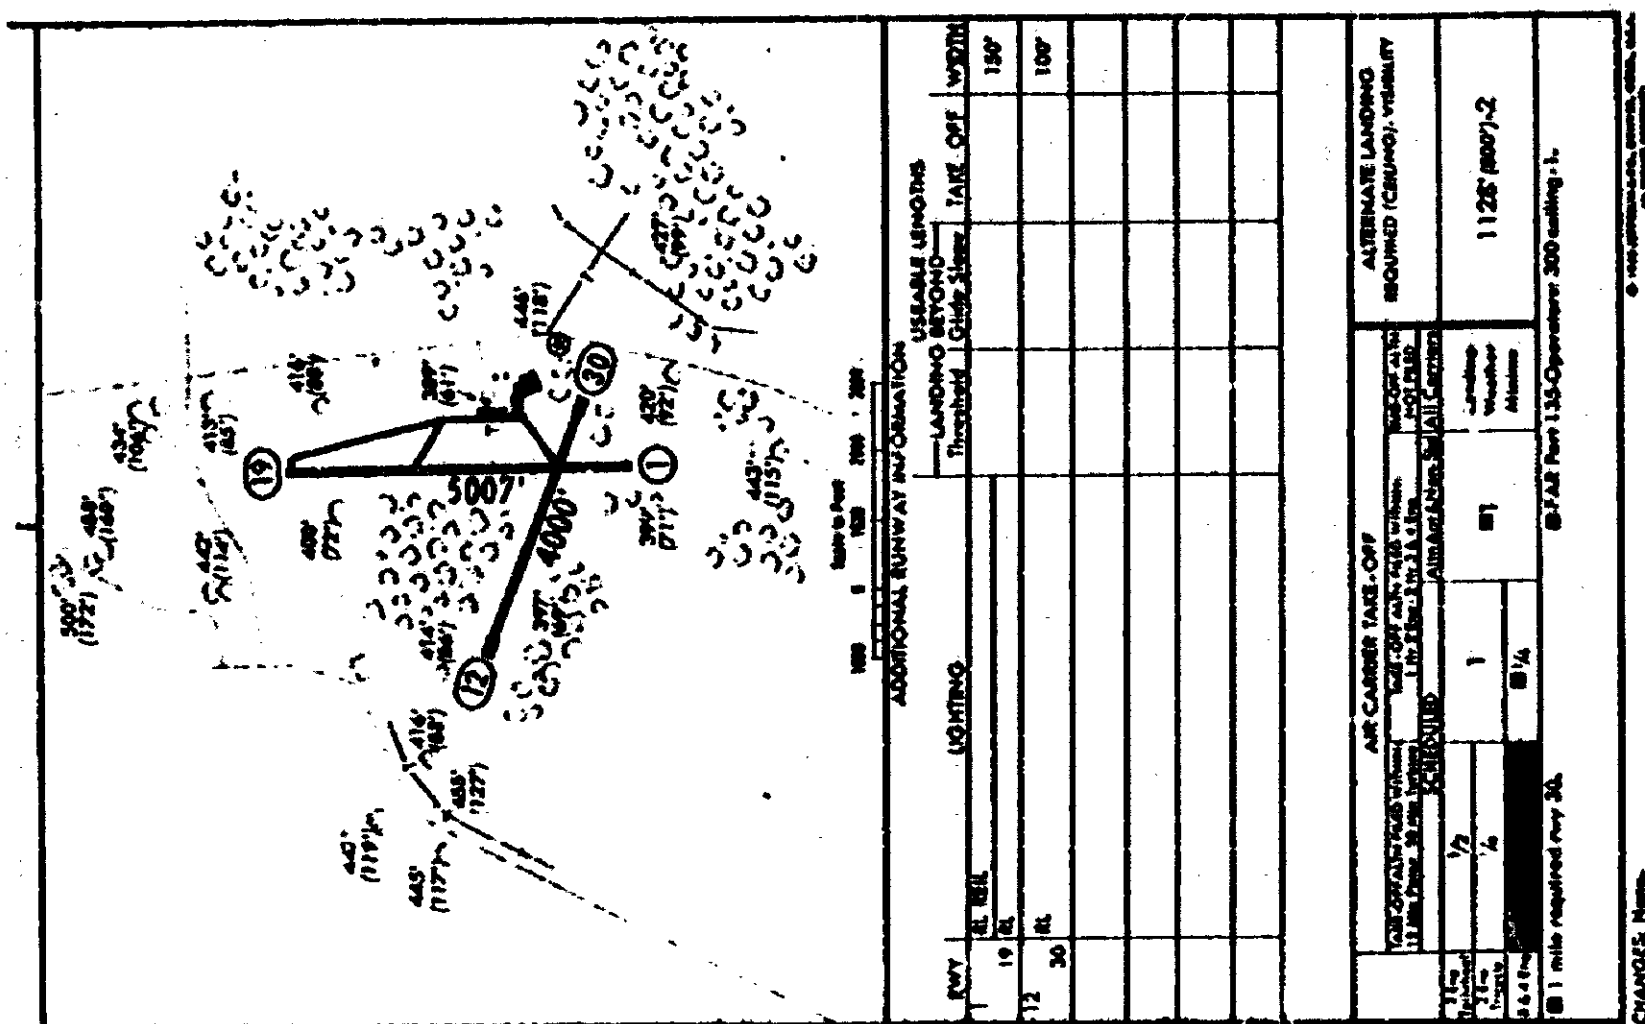
APPROXIMATE FLIGHT TRACK
BASED ON FLIGHT RECORDER DATA

The flight overflew Glens Falls at 3,000 feet and proceeded north for about 1 minute and 15 seconds at which time a left turn was initiated preparatory to return to the airport to land on Runway 19. During the last portion of this turn, the aircraft contacted trees on the northwest slope of Pilot Knob Mountain on a heading of about 180°, approximately 1 nautical mile east of Kattskill Bay, New York. It then impacted the face of a rock cliff, after which it dropped approximately 38 feet, became lodged between trees and the side of the mountain, and burned.
